Manhole Inspection Summary

Manhole # S07KK1013MH

Insp Date: **1/20/09 2:32 PM**

Location Address: **LITCHFIELD AVE**

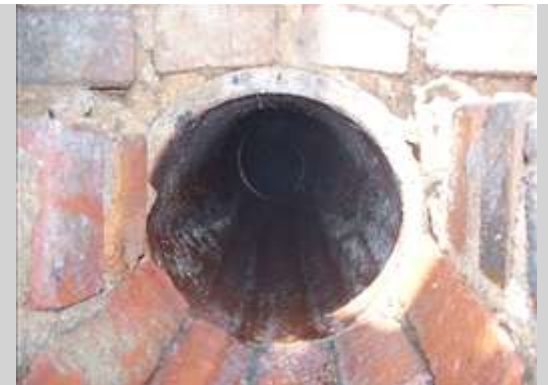
4 O'Clock Inflow

8 in. Circular Gravity Sewer
Pipe In @ 4 O'Clock

Pipe Height: (in.) Direct
Pipe Material: **Clay** ☐ Pipe Lined
Invert Depth: **6.55** (ft.) Flow Characteristics: **Slow**
Deposits: ☒ None ☐ Mud ☐ Sludge ☐ Debris ☐ Grease
Silt Depth: (in.) Deposits Extent:
Infiltration: **None** Pipe Seal Cond: **Sound**

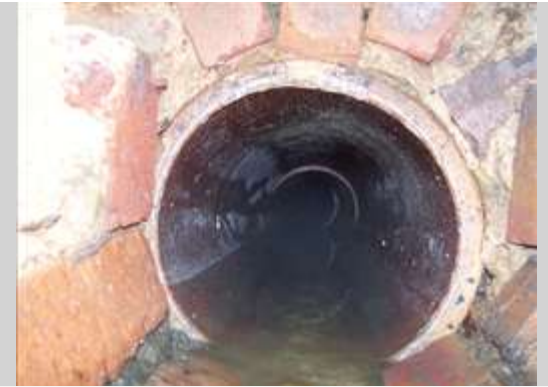
6 O'Clock Inflow

8 in. Circular Gravity Sewer
Pipe In @ 6 O'Clock

Infiltration: **None** Pipe Seal Cond: **Sound**
